**Flood Control Project Maintenance
Levee Inspections**

Maintenance Issue Types Only, Levee Inspection Report By Mile - Spring 2017

Reclamation District No. 0554 Walnut Grove

Waterway	Bank	Unit Miles	Inspection Start/End	Inspector
Unit No. 01 Sacramento River	Left	1.13	04/18/2017 04/18/2017	Herman Phillips

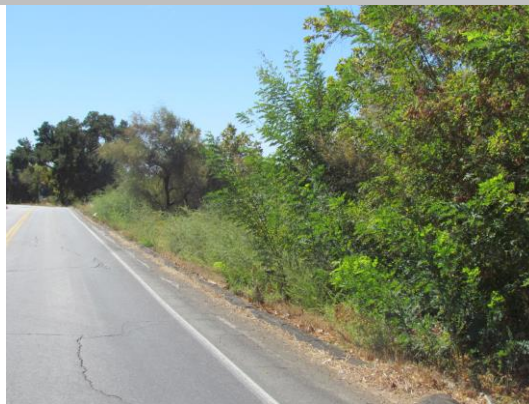
Photo 1 of 1 : SP_2017_RD0554_176_31_20170404_00007.jpg

LM Start	0.08	Rating **	U	Issue No.	31
LM End	0.36	Issue Type +	Ma	Location *	WS
Category	Earthen Levee		GPS Latitude/Longitude		
			Start	End	
Item	Vegetation		38.248638 °	38.244872 °	
			-121.509872 °	-121.511600 °	
DWR ID	DWR_RD0554_01_f_2016_31				
Comment Code					
V2 : Remove the wild growth other than native grasses from the levee slopes.					
Inspector Comment					
Remove the wild growth from the levee slope along the waterside levee section.

Looking downstream waterside levee slope from levee mile 0.08-0.30.

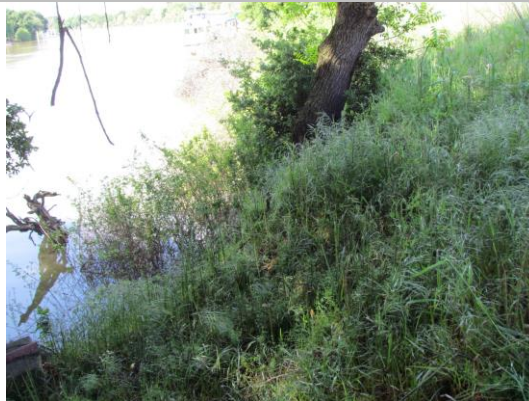
Photo 1 of 1 : SP_2017_RD0554_176_11_20170509_00057.jpg

LM Start	0.10	Rating **	U	Issue No.	11
LM End	0.10	Issue Type +	Ma	Location *	WS
Category	Earthen Levee			GPS Latitude/Longitude	
				Start	End
Item	Erosion / Bank Caving			38.248262 °	38.248262 °
				-121.509901 °	-121.509901 °
DWR ID	DWR_RD0554_01_s_2014_11				
Comment Code					
E1 : Note and monitor erosion site.					
Inspector Comment					
This is not a new erosion site, repairs are needed. One tree has fallen into the Sac River at the erosion site. This site can be seen better from the river by boat. The wild grapes blocks the view from the waterside shoulder looking down the slope.

RD 554 Waterside levee slope erosion into the bank, the wild vegetation growth blocks the view.

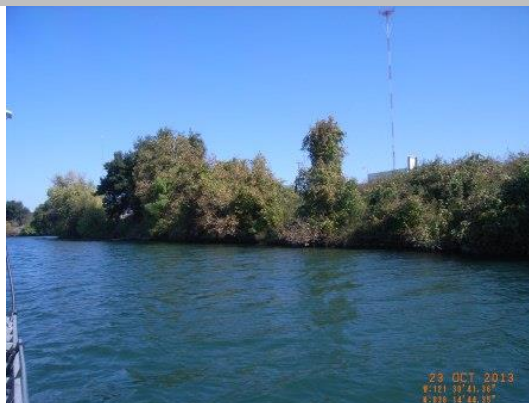
Photo 1 of 2 : SP_2017_RD0554_176_1_20170404_00001.jpg

LM Start	0.26	Rating **	M	Issue No.	1
LM End	0.36	Issue Type +	Ma	Location *	WS
Category	Supplemental			GPS Latitude/Longitude	
				Start	End
Item	2015 USACE Erosion Survey, DRAFT			38.246222 °	38.245017 °
				-121.510878 °	-121.511740 °
DWR ID	DWR_RD0554_01_f_2016_1				
Comment Code					
Inspector Comment					
2009 - Tension cracks on road on top of levee. Erosion into the levee slope and mass failure. 2013 - Short vertical sections at bank toe. 2015: No observed changes. [2015 Site ID: SAC_27-0_L]

USACE 2013 Photo #1

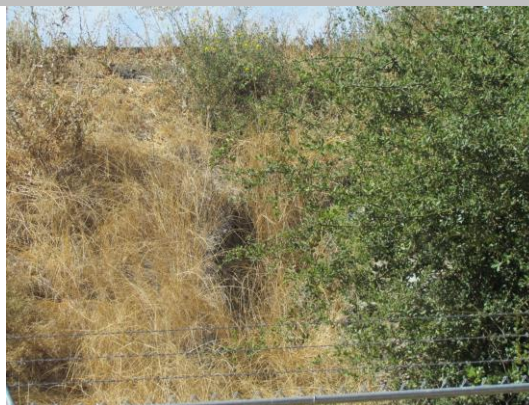
Photo 2 of 2 : SP_2017_RD0554_176_13_20170404_00005.jpg

LM Start	0.32	Rating **	U	Issue No.	13 (cont)	
LM End	0.32	Issue Type +	Ma	Location *	LS	
Category	Earthen Levee			GPS Latitude/Longitude		
				Start		End
Item	Erosion / Bank Caving			38.245389 °		38.245389 °
				-121.511085 °		-121.511085 °
DWR ID	DWR_RD0554_01_s_2014_13					
Comment Code						
E2 : Schedule repair of erosion site prior to the next inspection.						
Inspector Comment						
This erosion isn't repaired to date. Needs repairing.

This erosion site along the landside slope levee 0.32 has been reported and has not been repaired.

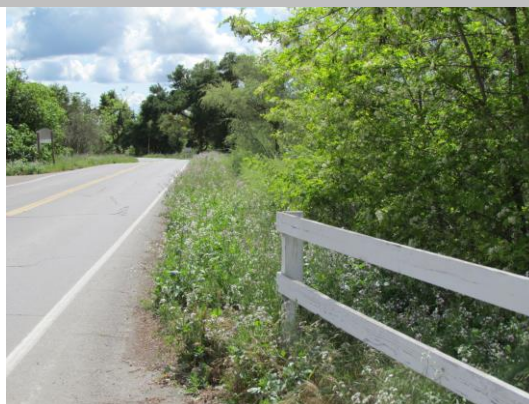
Photo 1 of 1 : SP_2017_RD0554_176_33_20170509_00058.jpg

LM Start	0.77	Rating **	U	Issue No.	33
LM End	0.87	Issue Type +	Ma	Location *	WS
Category	Earthen Levee			GPS Latitude/Longitude	
				Start	End
Item	Vegetation			38.240088 °	38.238913 °
				-121.515938 °	-121.516948 °
DWR ID	DWR_RD0554_01_f_2016_33				
Comment Code					
V2 : Remove the wild growth other than native grasses from the levee slopes.					
Inspector Comment					
Remove the wild growth other than native grasses along the shoulder of the waterside slope.

Looking downstream from levee mile 0.77 wild vegetation on the waterward slope and shoulder within the Veg. Site.
